ON-SITE AIR BAG INVESTIGATION

CASE NO. - 90-03  
FLEET - CORPORATE VEHICLE  
LOCATION - [REDACTED], INDIANA  
ACCIDENT DATE - [REDACTED], 1990

TRC/IU CASE NO. 90-03

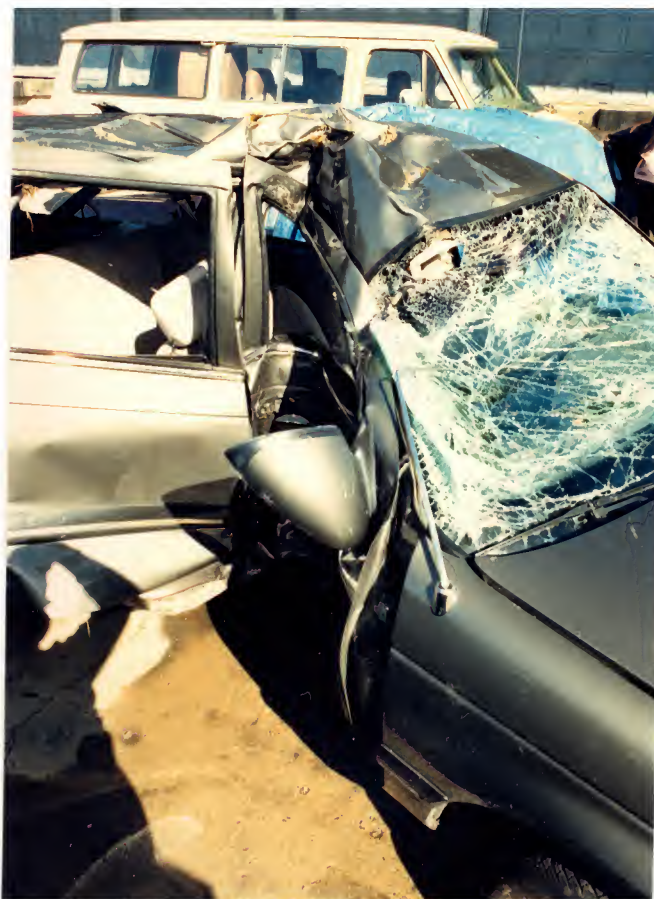
# 12 -- 1990  
 Indiana  
 TRC/IU: 90-03, Task: 0070  
 Closeup of tree impact

Event number:	1
Object Struck:	Medium-sized Tree
Damage location	
Damaged Plane:	Right
Vertical Location	
On Plane:	Mid-door
Direct Begins:	36.50 inches forward of right-rear axle
Length Direct:	14.00 inches
Field L:	42.00 inches
C <sub>1</sub> :	2.50 inches
C <sub>2</sub> :	16.00 inches
C <sub>3</sub> :	34.00 inches
C <sub>4</sub> :	28.50 inches
C <sub>5</sub> :	15.00 inches
C <sub>6</sub> :	7.25 inches
D:	+ 2.0 inches
Maximum Crush:	34.00 inches
Location:	C <sub>3</sub>
CDC:	61-RPAW-5
Damaged Components:	Right-front door, roof, windshield

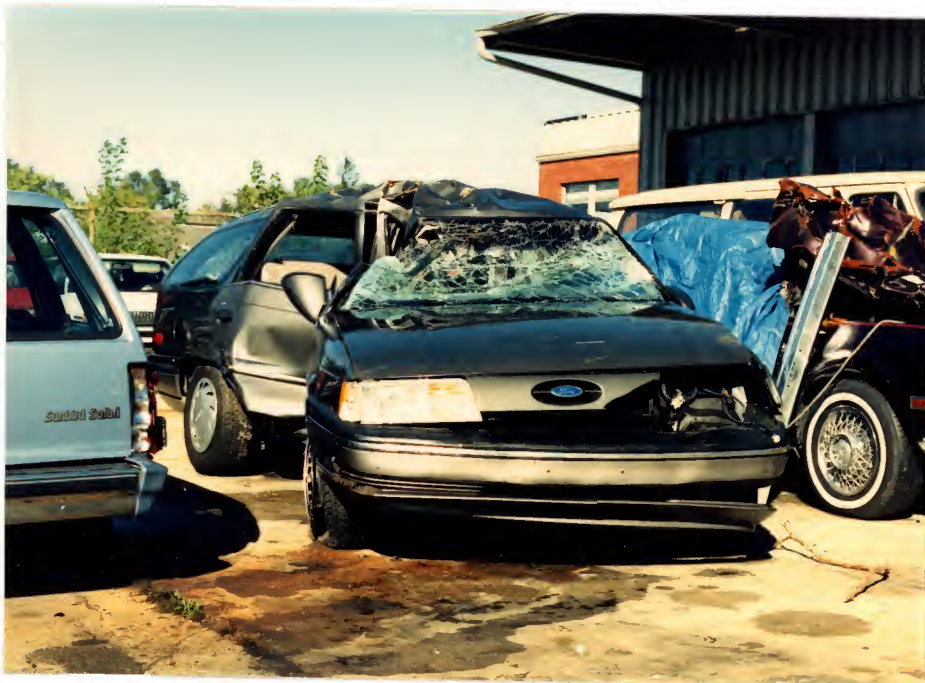
# 13 -- 1990  
Indiana  
TRC/IU: 90-03, Task: 0070  
Front right frontal view

Damage location	
Damaged Plane:	Front
Vertical Location	
On Plane:	Bumper level
Length Direct:	60.0 inches
Direct Begins:	Right-front bumper corner
Field L:	60.0 inches
C1:	2.0 inches
C2:	0.5 inch
C3:	0.0 inches
C4:	0.0 inches
C5:	0.0 inches
C6:	0.0 inches
D:	0.0 inches
Maximum Crush:	2.0 inches
Location:	C <sub>1</sub>
CDC:	09-FDLS-1
Damaged Components:	Front bumper

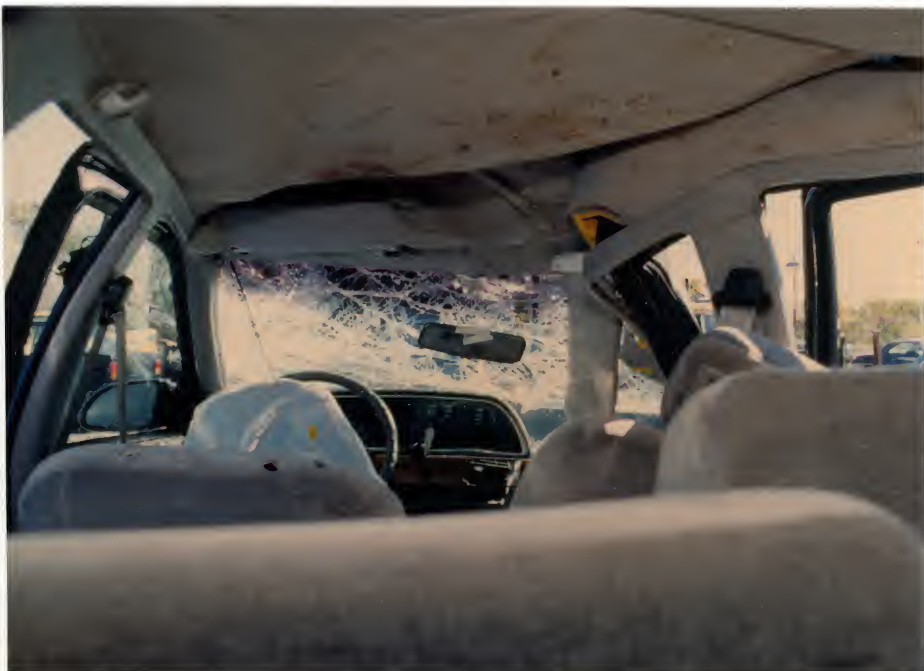
# 16 -- 1990  
 Indiana  
 TRC/IU: 90-03, Task: 0070  
 Interior viewed from rear

Damaged Components: Instrument panel and glove box, right-front passenger's seat, sunvisors, floor, right-front interior light, ashtray

Seat Performance Failures: Driver's right side seatback anchor is pulled away from cushion; right-front seat back deformed rearward and seat cushion deformed laterally
